## You Just Bought a New Laser. What Beam Shape Did You Get?

**Laser:** 4KW factory new laser, 808nm Diode with lens supplying a 12.5mm X 1mm beam, Robotworx rebuilt Motoman 6 axis robot.

**Process:** Heat treating and thermal cladding of metal parts primarily for oil and chemical industries and extreme environments.

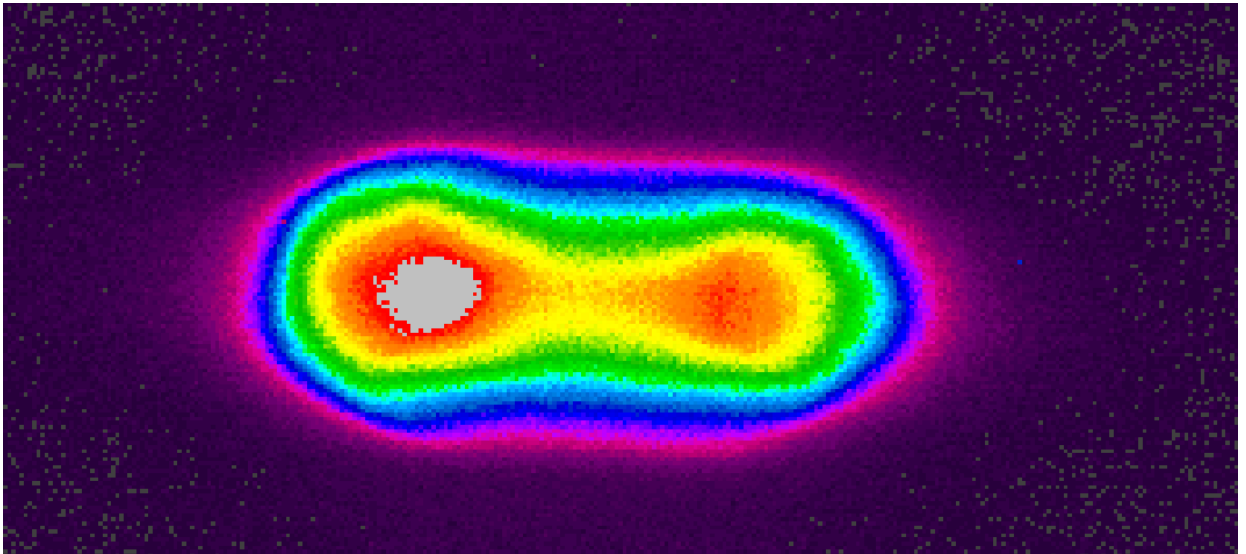
figure one

The beam on the target was not flat-top; it was barbell shaped and it had an uneven distribution of power along the long axis. This beam would never pass quality checks for parts processing.

The white portion of both pictures indicates the hottest part of the beam and should not be present during parts manufacturing. The laser delivers the advertised 4KW of power from the beginning of the duty cycle (as shown by the power meter) but the power was concentrated in two lobes at each end of the beam. (which damages the part) During later testing, the engineer discovered that the beam displayed other unusual shapes that were equally destructive to the part being processed. Eventually, the beam became stable and the power became evenly distributed but by that time in the duty cycle, the part was ruined.

The laser manufacturer never came up with a solution to the problem so the laser buyer reprogrammed his robot for an unplanned and unexpected warm-up period (off-target) to allow the laser to stabilize. Once the warm-up period finished, the laser began the heat-treating process and parts began passing the quality inspections.

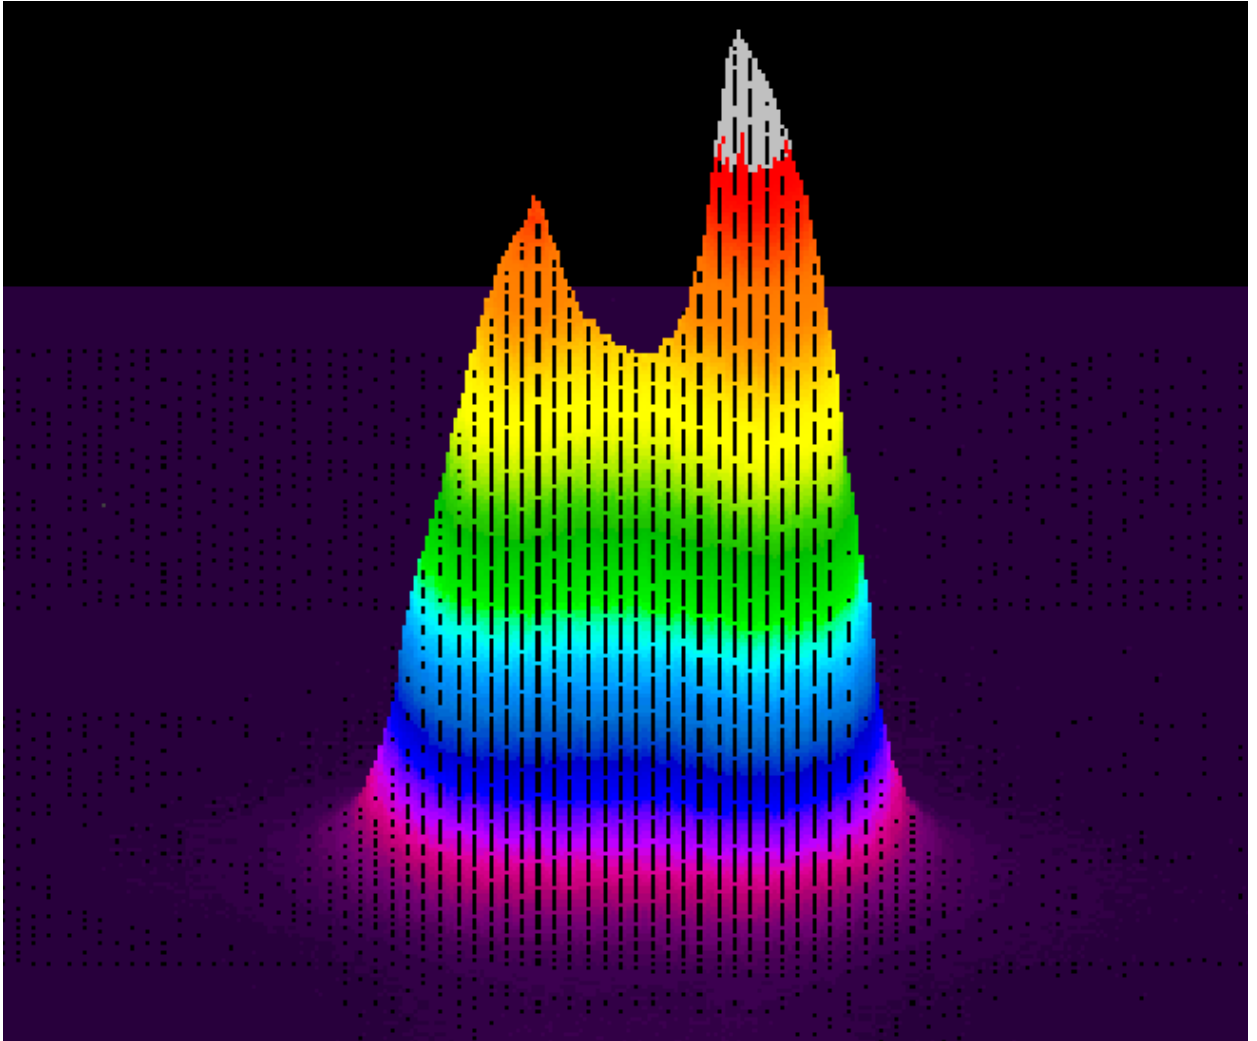
figure two

Figure two is the same as figure one above, (shown from the side), in a three-dimensional picture.

As you can see from the two pictures above, the laser heated the parts unevenly and was the reason the parts failed inspection.
