## You Just Bought a New Laser. What Beam Shape Did You Get?

**Laser:** 4KW factory new laser, 808nm Diode with lens supplying a 12.5mm X 1mm beam, Robotworx rebuilt Motoman 6 axis robot.

**Process:** Heat treating and thermal cladding of metal parts primarily for oil and chemical industries and extreme environments.

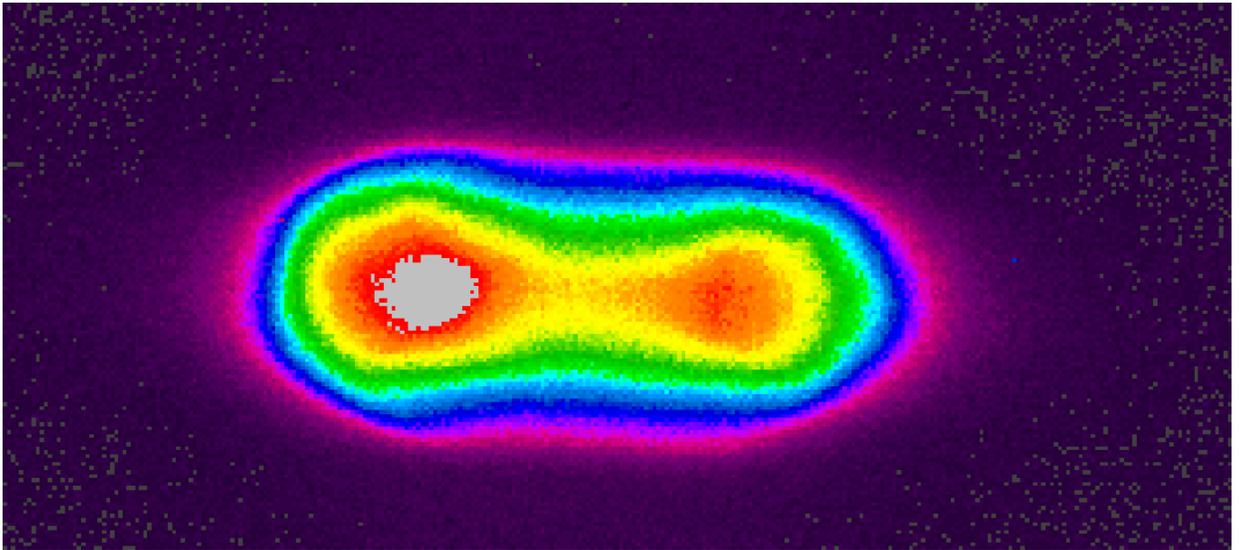
figure one

The beam on the target was not flat-top; it was barbell shaped and it had an uneven distribution of power along the long axis. This beam would never pass quality checks for parts processing.

The white portion of both pictures indicates the hottest part of the beam and should not be present during parts manufacturing. The laser delivers the advertised 4KW of power from the beginning of the duty cycle (as shown by the power meter) but the power was concentrated in two lobes at each end of the beam. (which damages the part) During later testing, the engineer discovered that the beam displayed other unusual shapes that were equally destructive to the part being processed. Eventually, the beam became stable and the power became evenly distributed but by that time in the duty cycle, the part was ruined.

As you can see from the two pictures above, the laser heated the parts unevenly and was the reason the parts failed inspection.

The laser manufacturer never came up with a solution to the problem so the laser buyer reprogrammed his robot for an unplanned and unexpected warm-up period (off-target) to allow the laser to stabilize. Once the warm-up period finished, the laser began the heat-treating process and parts began passing the quality inspections.

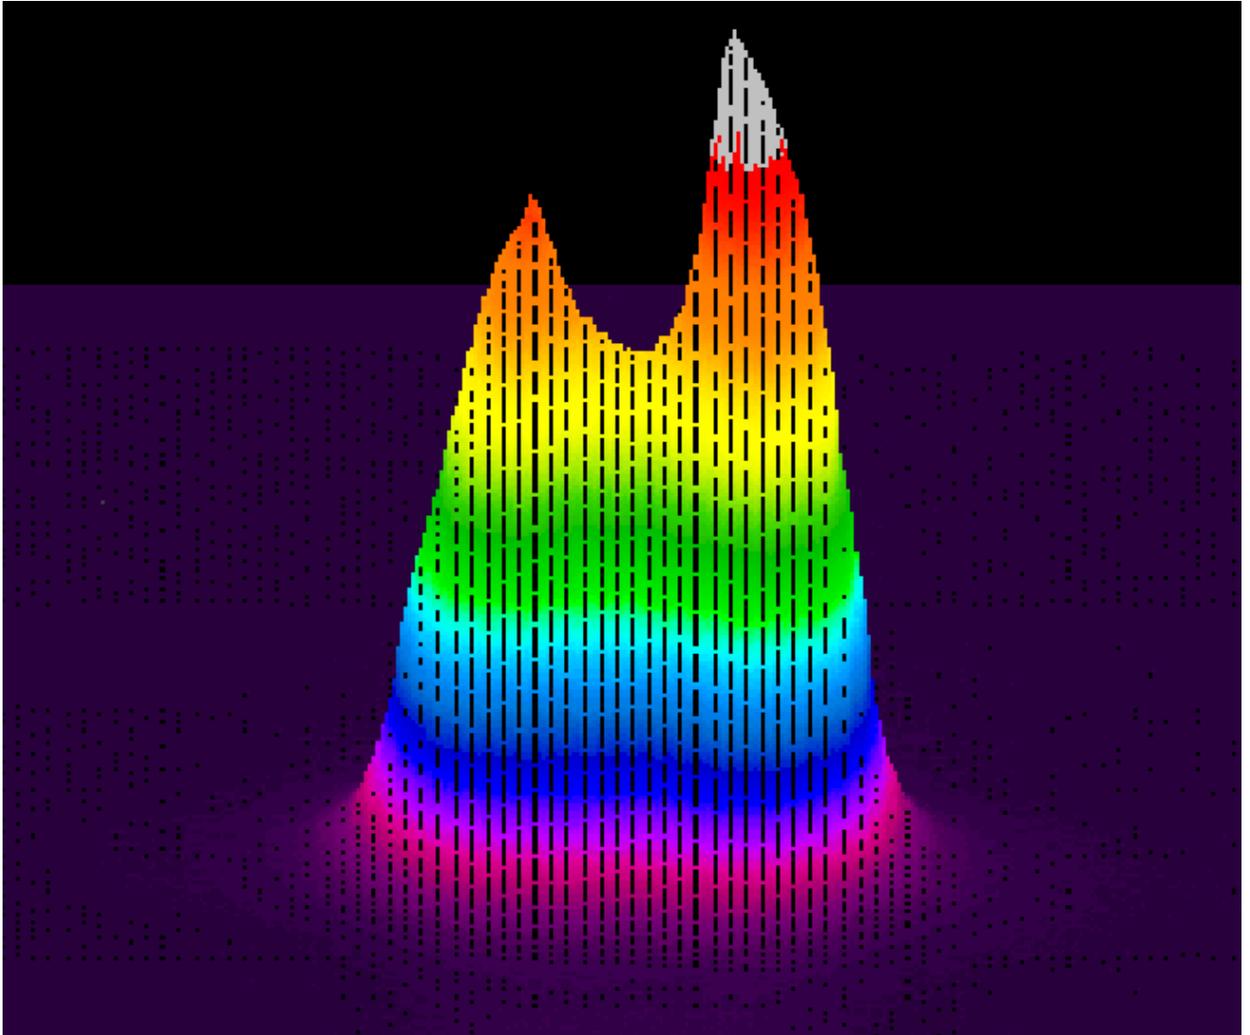
figure two

Figure two is the same as figure one above, (shown from the side), in a three-dimensional picture.
