Water Cooled Sensor

Corrosion Report

Symptoms and Recommendations

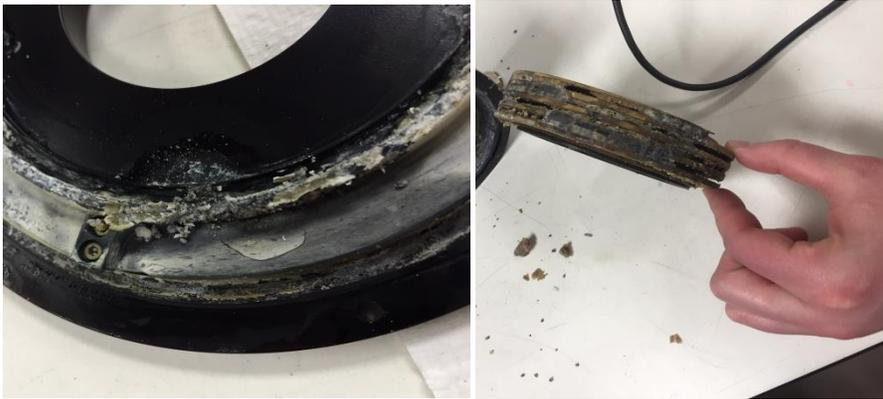
Figure 1

Through the last several years in the calibration lab, we have seen an increase in the number of sensors that are being processed that have excessive corrosion. This corrosion typically presents itself in the form of “pitting” in the internal chambers, and is frequently characterized by the presence of films and build up in the internal chambers. In Figure 1, you can see examples of the “pitting” typical in corroded sensors, and in Figure 2, you can see the build up in the internal channels.

In order to understand this concern further and to work towards resolution of this concern, we requested water samples from several customers. These water samples have been analyzed and have been found to contain high chloride levels, and a wide range of pH values. Our recommended range for pH values is above 4 and below 9, and we recommend that chloride levels are kept low to avoid corrosion.

In addition to the pH and chloride levels, there were a wide range of contaminants that were found in the water. This contamination was mostly metallic in nature, but there was some presence of organic compounds noted. Upon further investigation, we found that systems with very high rates of corrosion issues were using a closed-loop system which pumped the contaminated water back through the chambers of the sensors, causing further damage to the sensors. This resulted in receipt of a murky water sample from customers, with apparent rust and corrosion in the water itself. Based on this finding, we’d recommend that the water used in these systems is flushed every 6-12 months, and that a biocide is introduced to the sensor environment to prevent the buildup of bacteria and algae.

In summary, there are several steps that can be taken to prevent and mitigate the effects of corrosion: ensure that the water is pH balanced, and that there are low chloride and metallic ions in the water. If your sensor exhibits behavior inconsistent with its normal use, i.e. through slowing of water through the sensor channels, abnormally high power readings, or longer cool-down times, we recommend returning the equipment for servicing. Additionally, we recommend taking care to blow out the sensor channels with clean, dry, compressed air when the sensor is put away to prevent water from sitting inside the channels and causing accelerated corrosion.

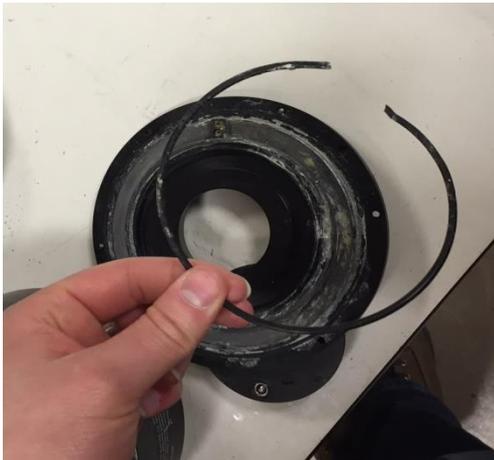
If corrosion is at play in your sensor, there are symptoms that can be identified that would trigger a return for servicing. Perhaps the most common symptom of corrosion in your sensor is that the housing of the sensor is leaking water. In these cases, corrosion has built up inside the sensor, forcing water to breach the o-ring barrier or to eat away at the channel holding the o-ring, and water will either spray or drip onto the absorber disc. Once the sensor has corrosion built up inside, there is also an increased risk that the o-rings have melted and the disc may be damaged. See Figure 3 for an example of an o-ring that has been melted by a sensor that has not cooled properly, and Figure 4 for an example of a channel that has been corroded to the point that the integrity of the channel has been compromised.
