NanoScan

Common Causes of Damage to Scanheads & Reasons for Out-of-Tolerance Conditions

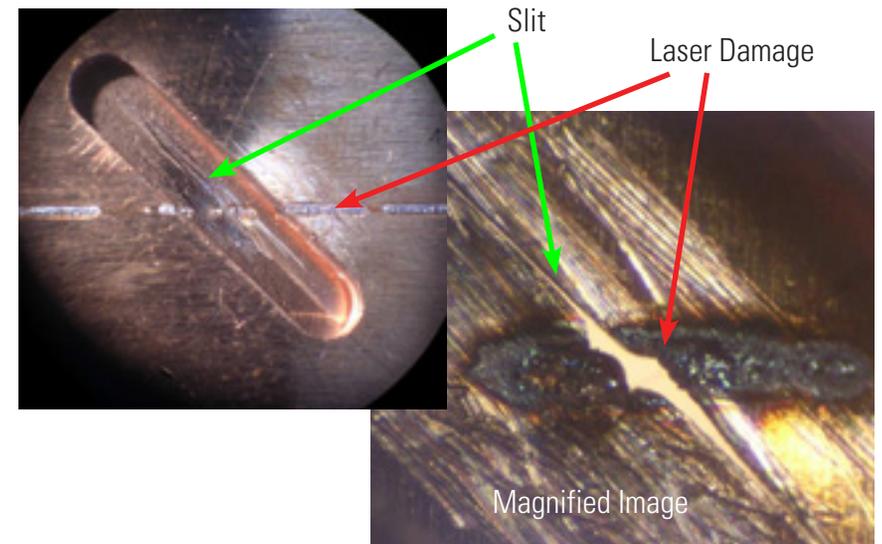
Laser damage includes cut or distorted slits, damaged detectors, damaged power windows, warped optical encoder and circuit failure, and cut signal cables.

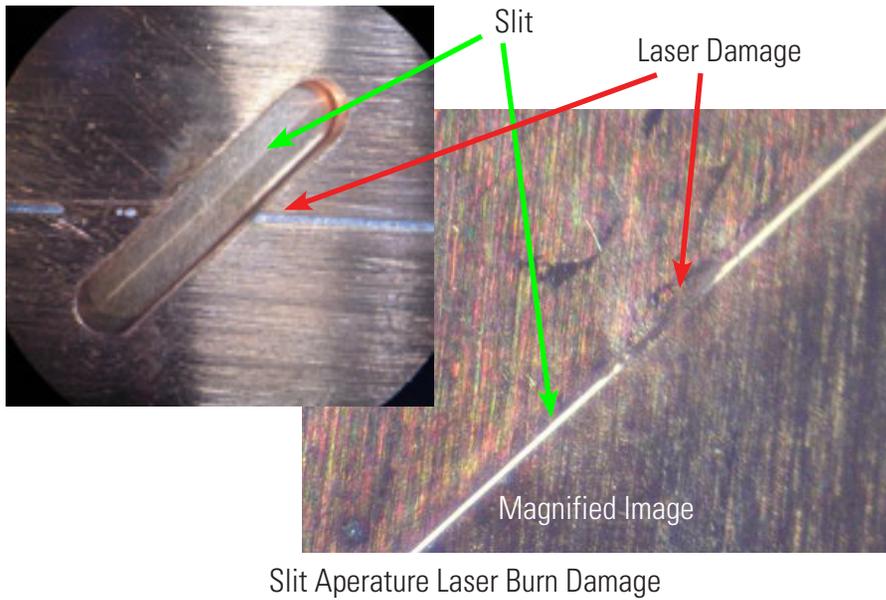
Slit Aperture Laser Cut Damage

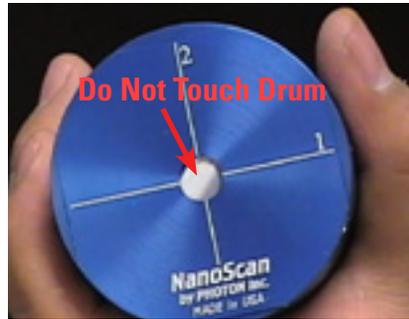
Touching or contacting the slit substrates; for example, attempting to clean the slit with a cotton swab, or positioning a source, such as an optical fiber, so that it contacts the slit substrate will damage the slits.

The air slit and pinhole aperture substrates are very thin and extremely fragile. Any physical contact will likely damage them. Treat the slits with care; because of their fragility, never touch them with anything!

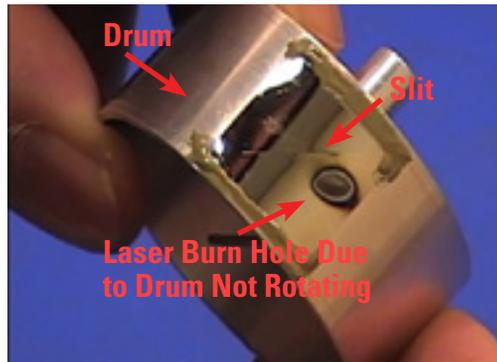
Particle contamination results in plugged slits, and most likely is due to operation in a high particulate environment, or attempts to clean the slit.

If aperture contamination is suspected, it is recommended that the unit be returned to Ophir-Spiricon for aperture inspection, cleaning or replacement, and recalibration.

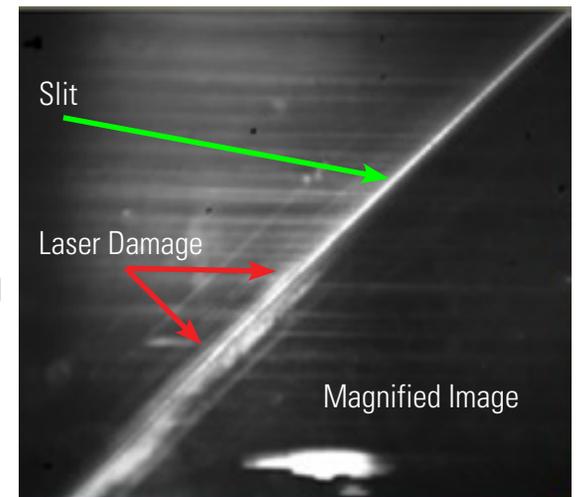
Laser damage to slits is caused by CW beams with excessive irradiance, pulsed beams with excessive peak irradiance, pulsed beams with excessive fluence, and long-term exposure to high average power CW or pulsed beams.

Excessive Laser Irradiance Slit Damage

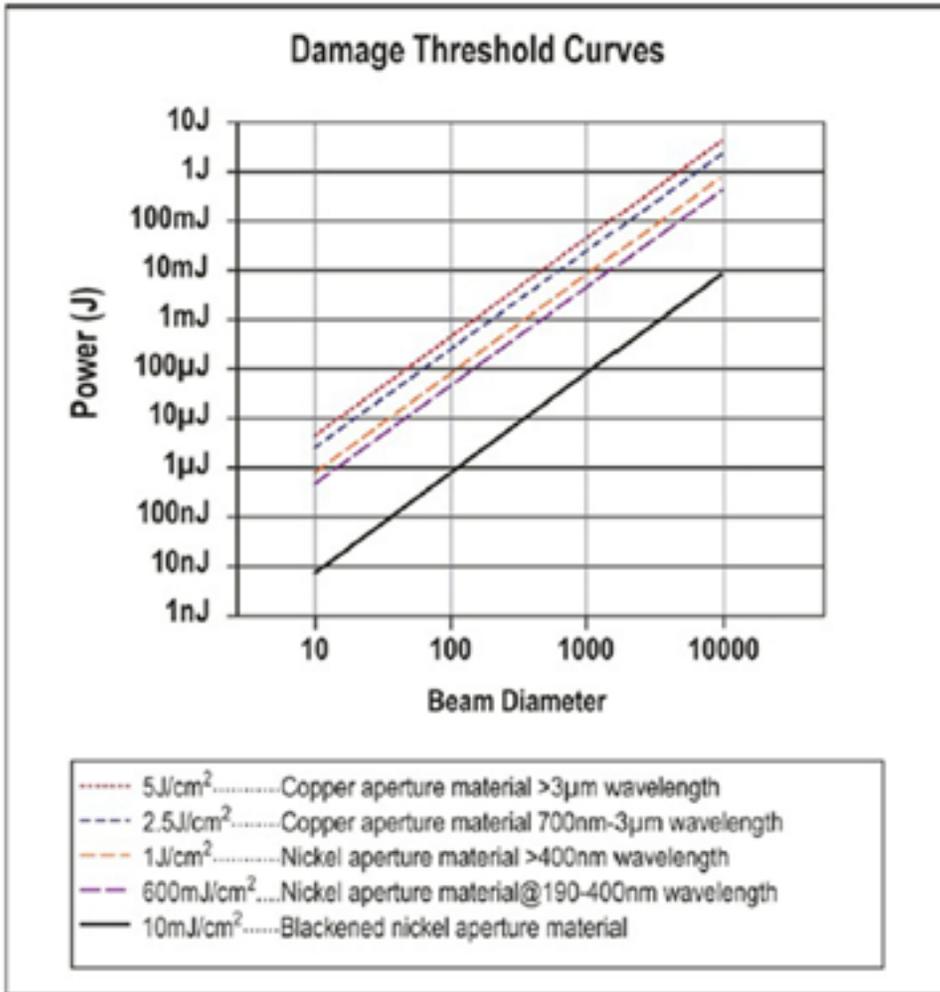
These values are also shown in the Pulsed Damage Threshold curves given in figure 2.

Figure 2. Pulsed Laser Damage Thresholds for nickel alloy and copper slit apertures

For pulsed lasers, specifically those in the picosecond and femto-second regimes, it is very likely that the peak irradiance exceeds damage thresholds but the fluence per pulse is very low. In this case it is unlikely that instantaneous damage will occur, but long term damage from micromachining is likely. In this case,

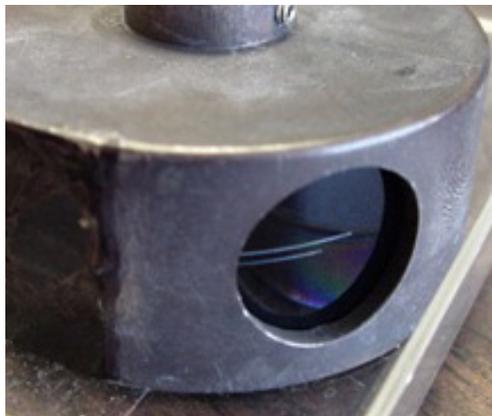
Damage to the power window can occur at levels below the damage threshold for the slit aperture, specifically for the P75 Wratten Filter option, which has been discontinued as a product offering.

Power Window Damage
